Smoke and Dye-Water Observation Summary

Western Run Pilot Project - Baltimore Maryland

Sketch (NTS)
Dye Test 120

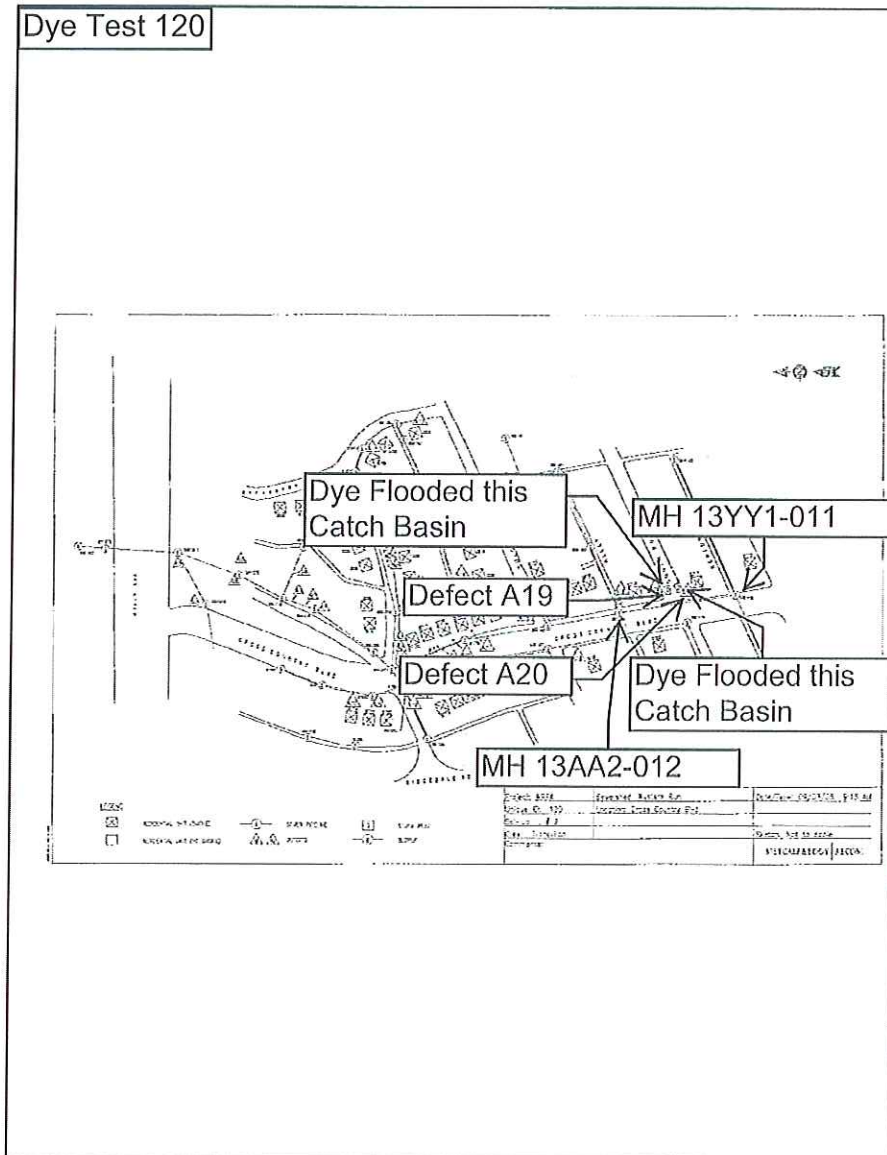
Sketch No: 120

Dye Flooded this
Catcg Basin
Defect A19

Dye Flooded this
Catch Basin
Defect A20

Additional Comments: A20 - NO DYE SEEN IN SANITARY SEWER.

A19 NO DYE SEEN IN SANITARY SEWER.
